The Restoration of a Bronze Plaque from Benin

By LESLIE R. LANGTON

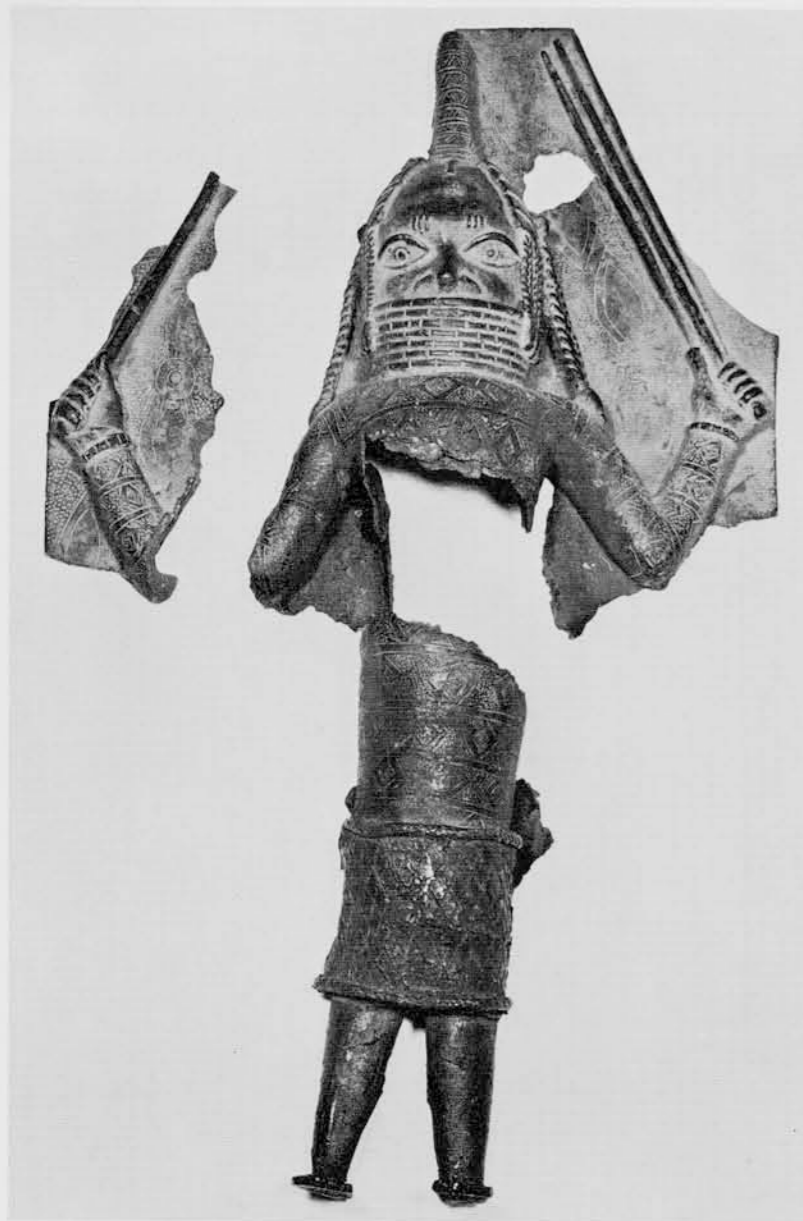
The University Museum plaque: (left to right) before restoration; the back showing 'burn-on' repair; the back of the upper section, the upper right arm bent in to the body; the top corners after treatment and before hard soldering.

In the 20th century the plaque suffered further damage. The right forearm was broken off at the elbow. The right upper arm and shoulder was bent and very badly cracked. There was another fracture completely across the chest. The plaque was in three main pieces.

The detailed examination revealed that the damage at the right shoulder was in fact another fragment (the fourth), as the bronze here had cracked right through and was only held in position by the core. The right upper arm was bent inwards by 5 degrees to the body.

This had to be taken in stages. As in simple repairs, it is usually best to start with the largest fragment and fit what one can to it. The face and right shoulder fragment was first attempted. This was carefully flame annealed and the core removed from the damaged section. This allowed the smaller shoulder fragment to be removed. Hardwood forms were then carved to fit the inside and outside of the bronze at the area needing reshaping. Gentle but even pressure was applied with a "G" clamp. Working about a half degree at a time, constantly re-carving hardwood forms to suit, and annealing as required, the bent area was worked back to its original shape. Similar treatment was applied to the smaller shoulder fragment until the two fitted correctly. The edges of both fragments were then carefully filed to show a 'clean edge' of bronze and prepared for hard soldering. The two fragments were then set up on a brazing hearth, face downwards, as the hard soldering was to be attempted from the back. Johnson Matthey's "Silfos" was used as this hard solder has a reasonably low melting point, 750°C, and a characteristic of 'blobbing' and 'filling' rather than 'flowing.' It was essential that a strong joint should be obtained but that no solder should run through the joint and mar the intricate design on the front surface of the plaque.

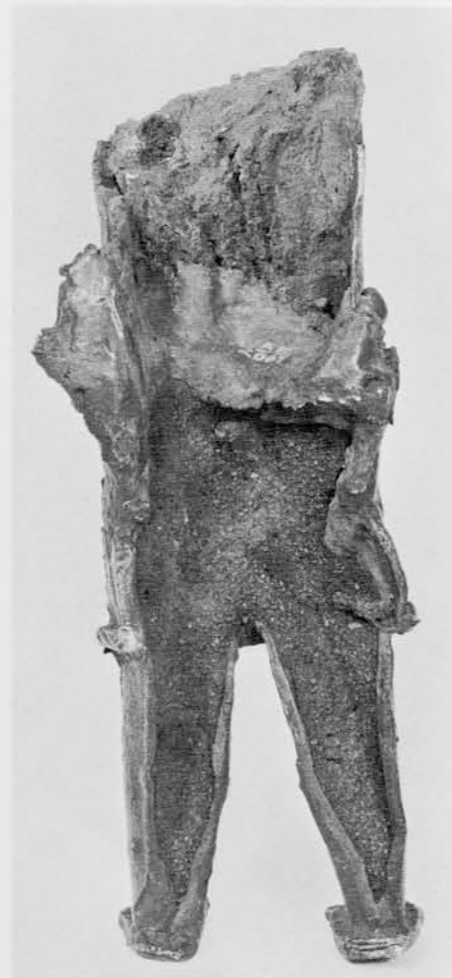
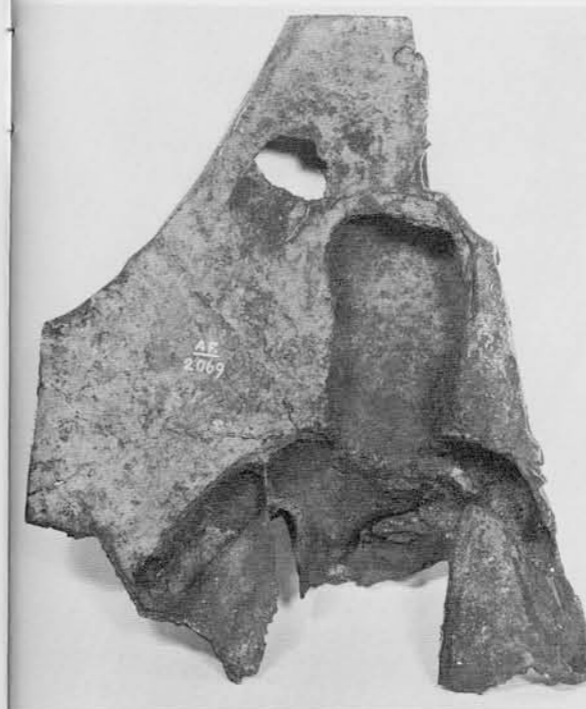
The 15th-16th century bronze was in excellent condition consistent with its age, except for the area between the elbows and from 1 cm. above the fracture across the chest down to the 19th century casting. This area was extremely thin—1 mm. to 0.25 mm.—and in very poor condition, being partially mineralized and 'burnt', due most probably to overheating during the 'burn-on' casting of the skirt and legs, which was 3 mm. to 5 mm. thick and in excellent condition.

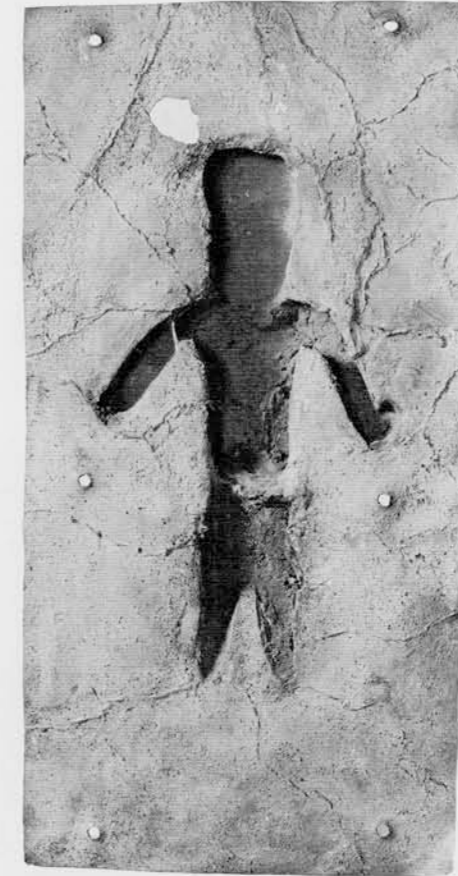
The back of the completely restored plaque, the face of which is shown on page 2.

The pattern was completed as previously described. Sections of the core which had been removed for this work were replaced with a suitable adhesive. An outline showing the correct position of the bottom of the dress and the feet was superimposed to give a better appreciation of the plaque as originally designed. Finally, all the made-up sections were coloured to suit the remaining fragments.
