The Iron Age Architecture at Hasanlu: An Essay

ROBERT H. DYSON, JR.

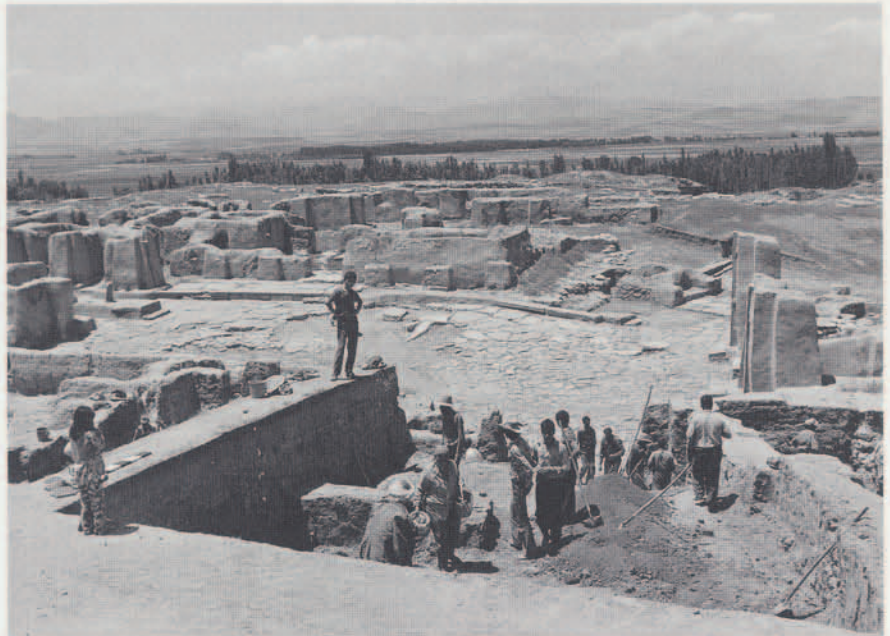
1 General view looking southwest over the Lower Court during excavations of 1974. Stelae of Burned Building IV are at center right, the buttressed east facade of Burned Building I-East lies behind standing central figure, and the portico of Burned Building II may be seen at left center. (Photo courtesy of the Hasanlu Project)

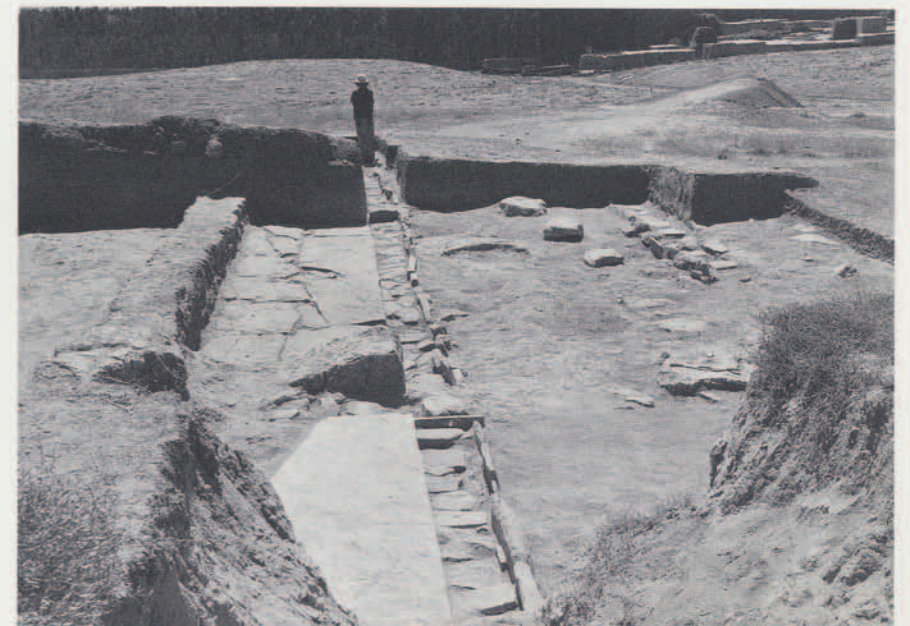
5 A view looking downhill shows a well-preserved section of the period IVB western road. At the left stands a clay bench, stone pavement, stone drain, and hard-packed clay road surface. Part of the parallel stone drain may be seen at the upper right. The wall against which the bench stood has been robbed out at this point, but is preserved higher up the slope. The pavement was interrupted in this area by widely spaced projections across it, as seen in the center. (Photo courtesy of the Hasanlu Project)

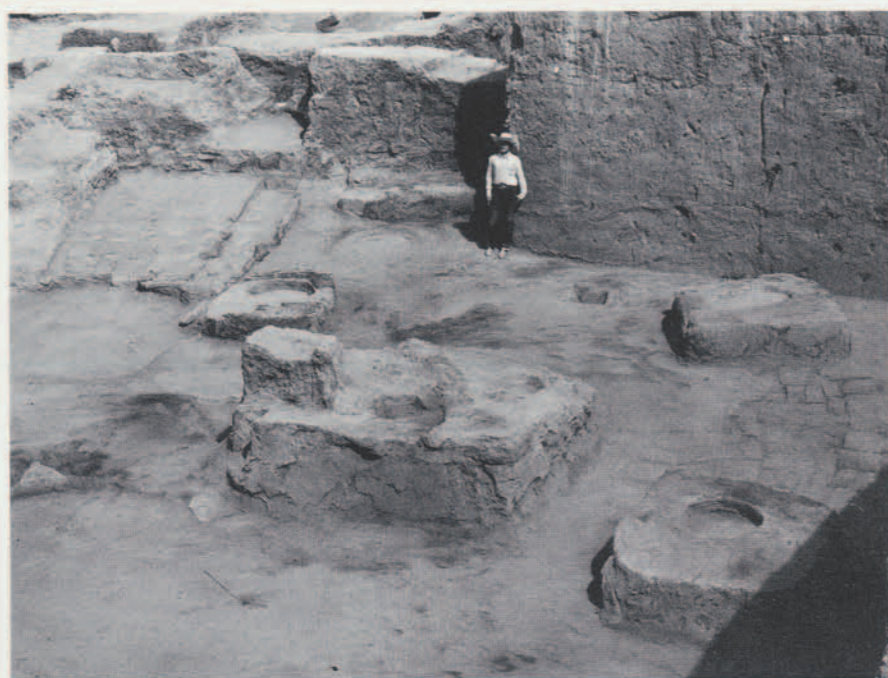
9 A view of the fire altar(?), column bases, bench, and paved area (in the northwest corner, upper left) of the columned hall of Burned Building V, as it was in 1972. Fired and plastered superimposed surfaces stood at the lower left side of the altar. Note the brick paved floor at the center right. (Photo courtesy of the Hasanlu Project)

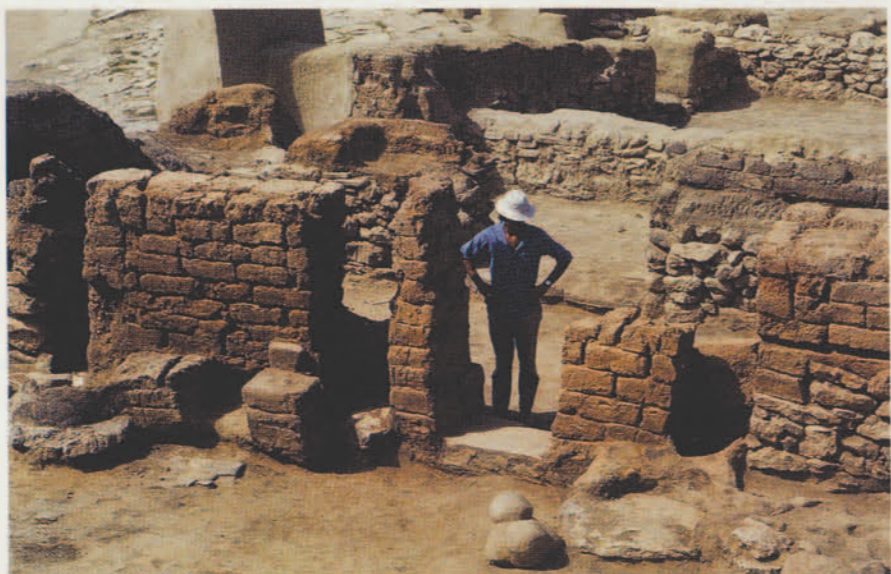
11 View of the doorway leading from the anteroom into the columned hall (foreground) of Burned Building IV-East. In period IVC the doorway was a wide opening with three pairs of wooden columns supporting the lintel. In period IVB the doorway was filled with brick, enclosing the columns and leaving only a small opening. Two additional columns set in the hall also partly blocked the opening.

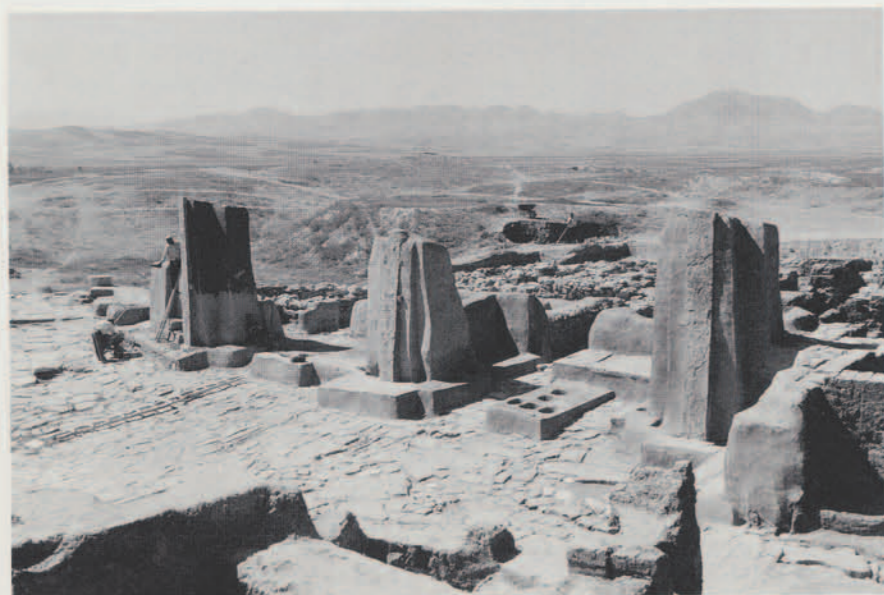
12 Twin porticoes flanked by undecorated stone stelae at the north end of the Lower Court (paved area). Gateway into the Court is at center left. Note the round holes left by the burned-out columns. Fresh mud plaster is being applied to protect the ruins. The stele at the right measures 4.5 m in height. (Photo courtesy of the Hasanlu Project)

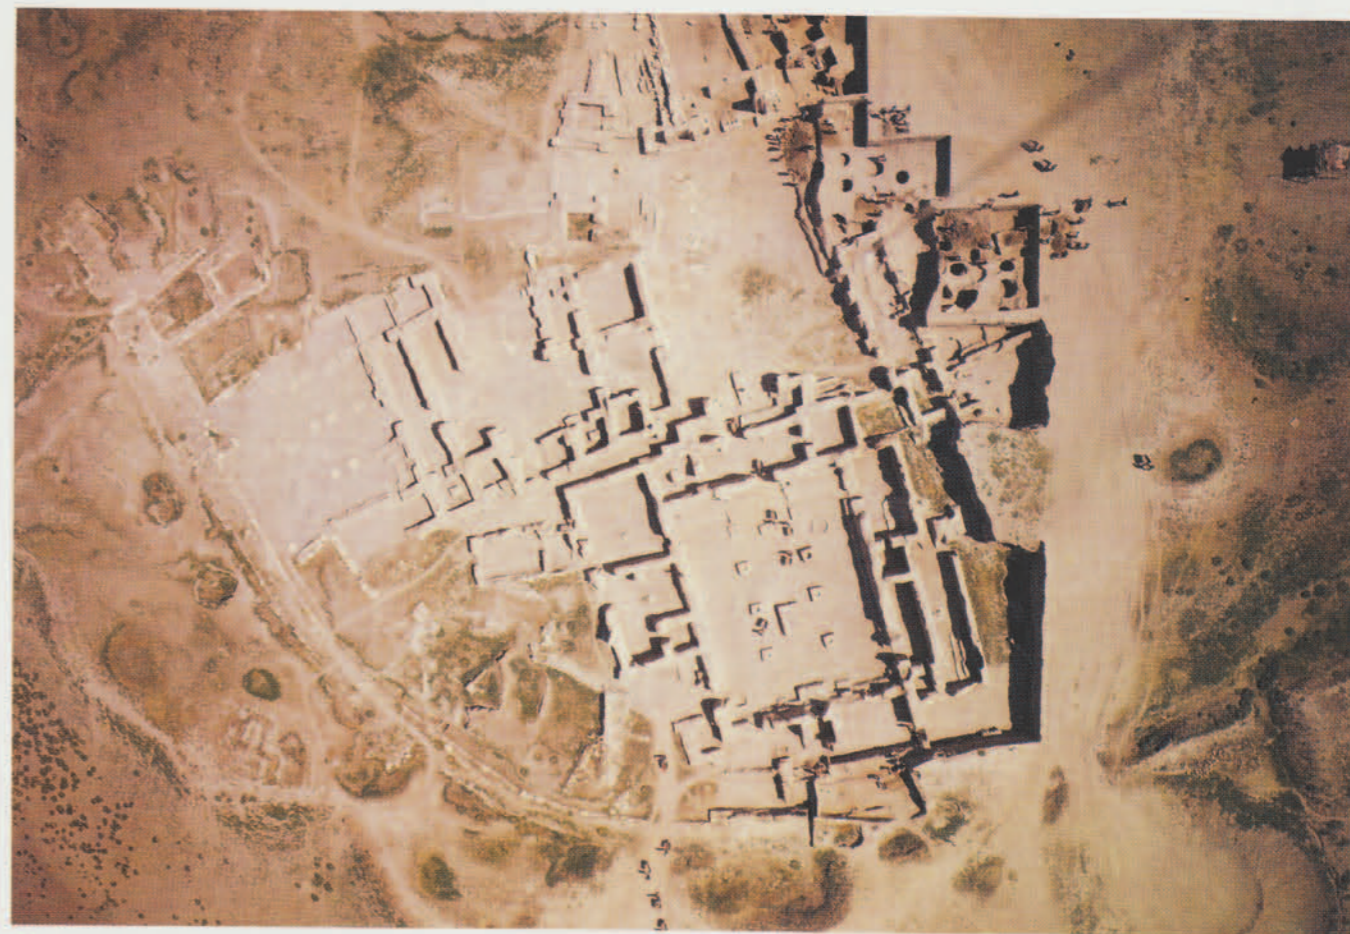
13 Air view of the 1972 excavations at Hasanlu showing the temple (Burned Building II, upper center), Burned Buildings I-East and -West (center right), Burned Buildings IV (lower center) and V (lower left). The later Urartian fortification wall of Hasanlu period IIIB curves around the center and upper edge of the picture. Pits dug in period IIIB may be seen on surfaces in excavated squares in the lower left. (Photo by Julian Whittelsey for the Hasanlu Project)

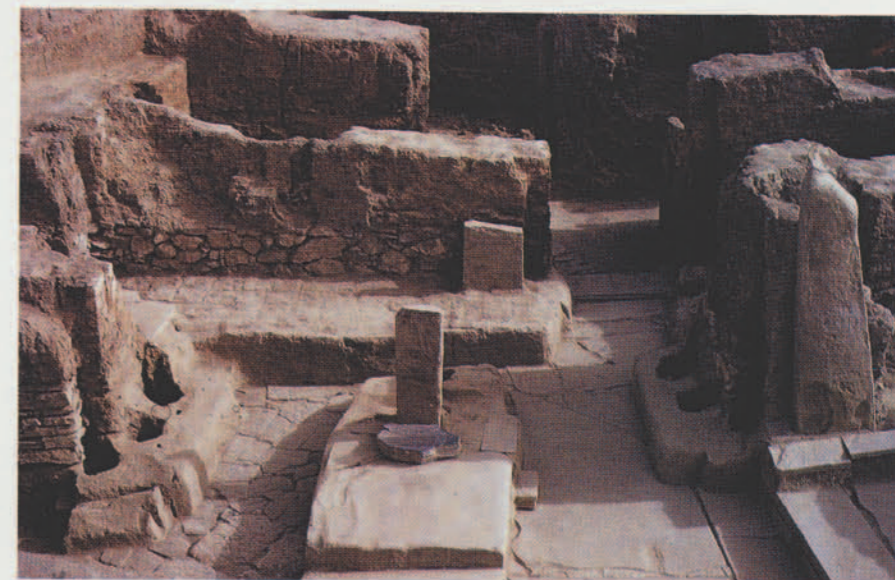
14 Fully excavated and cleaned portico of Burned Building II in 1960, showing the central platform with its bluish water-worn stone sitting in front of an undecorated stele. A second stele stands on the brick bench behind and a taller stele stands against the front wall at the right. Note the burned holes at right and left showing the positions of the round columns which once supported the facade. The door at the back led into the anteroom; the columned hall beyond had not yet been excavated. (Photo courtesy of the Hasanlu Project)

found standing erect; lying flat before the stele was a smooth, waterworn slab of bluish-grey stone (Fig. 14). Another stele, broader than that on the platform and only 0.9 m high (although perhaps incomplete), had been placed on a low mud-brick bench against the back wall of the portico, aligned with the platform stele. A third limestone stele, 3 m high with an asymmetrically pointed top, stood against the outer facade of Burned

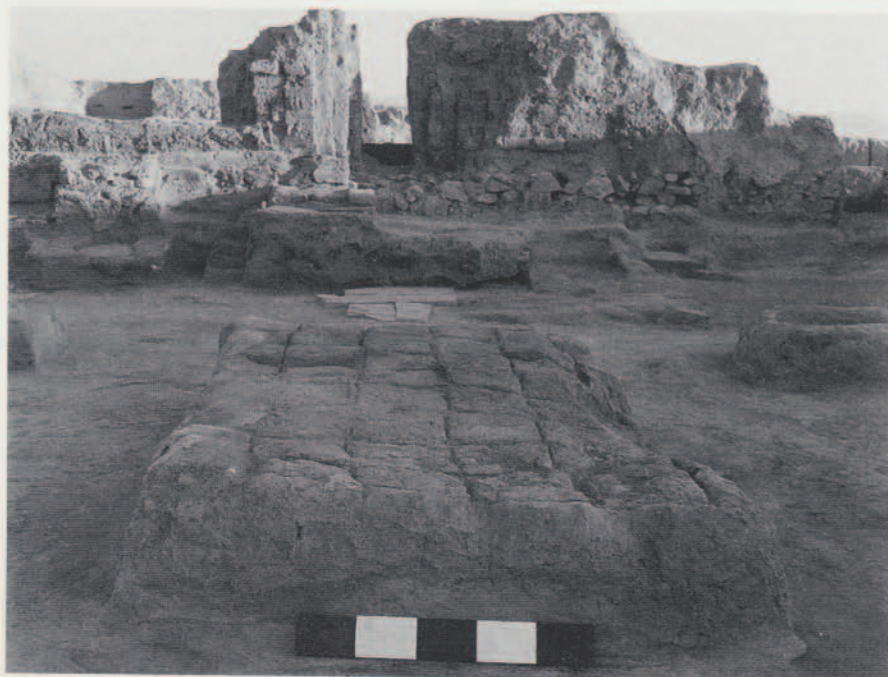
15
The south end of the columned hall of Burned Building II showing the raised hearth (altar?) on the central axis of the hall and the platform and stepped-recessed doorway in front of the cella(?) at the far end. Stone and mud plaster footing for columns may be seen to the left and right of the rear platform and just right of the southwest corner of the hearth. (Photo courtesy of the Hasanlu Project)

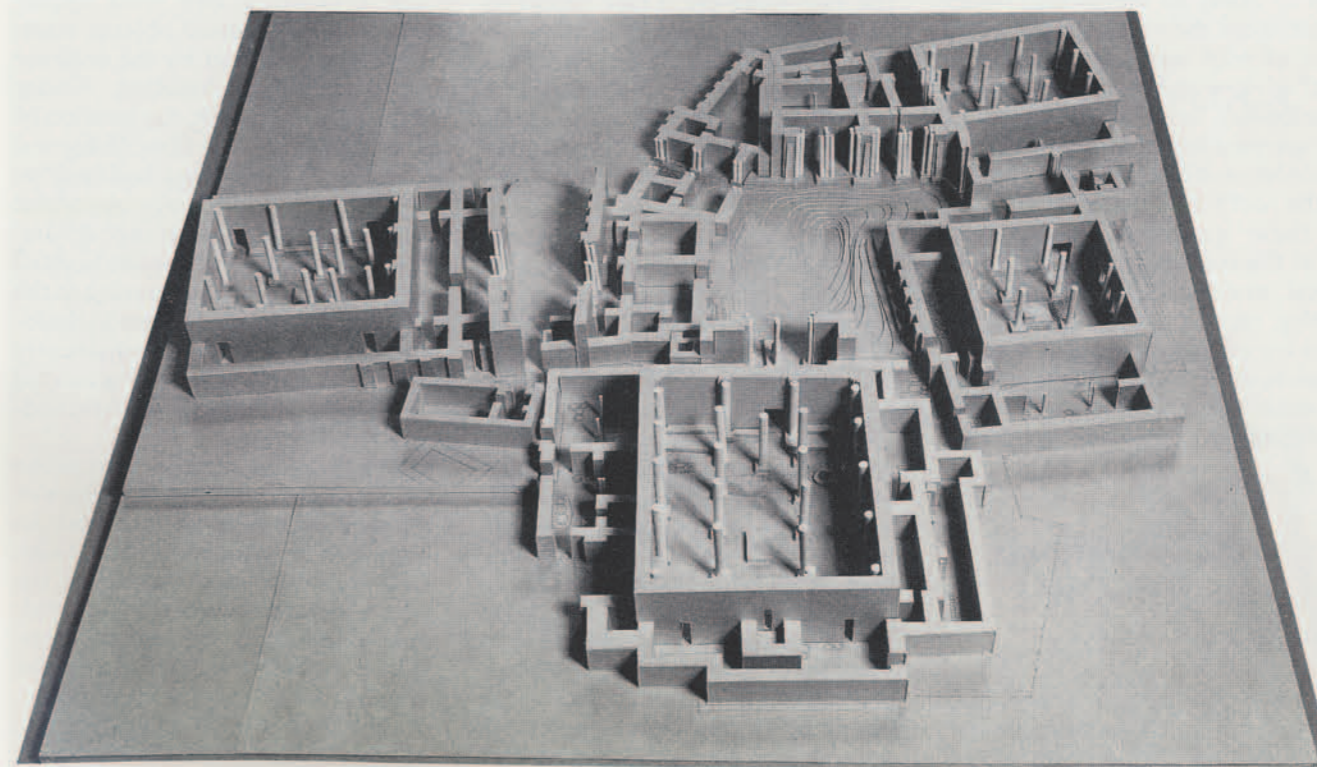
17
Model of the main building complex excavated for period IVB looking across Burned Building II (center front) toward the double portico and stelae of Burned Building IV-IV East. Building V is at center right and Burned Building I-West at center left. (Model by Thomas Applequist for the Hasanlu Project)

excavated evidence indicated a minimum height of 7 m for the side walls of the columned hall in Burned Building II, but other buildings may have been lower. In the model Applequist has made all of the columned halls this same height, recognizing that in reality they probably varied.

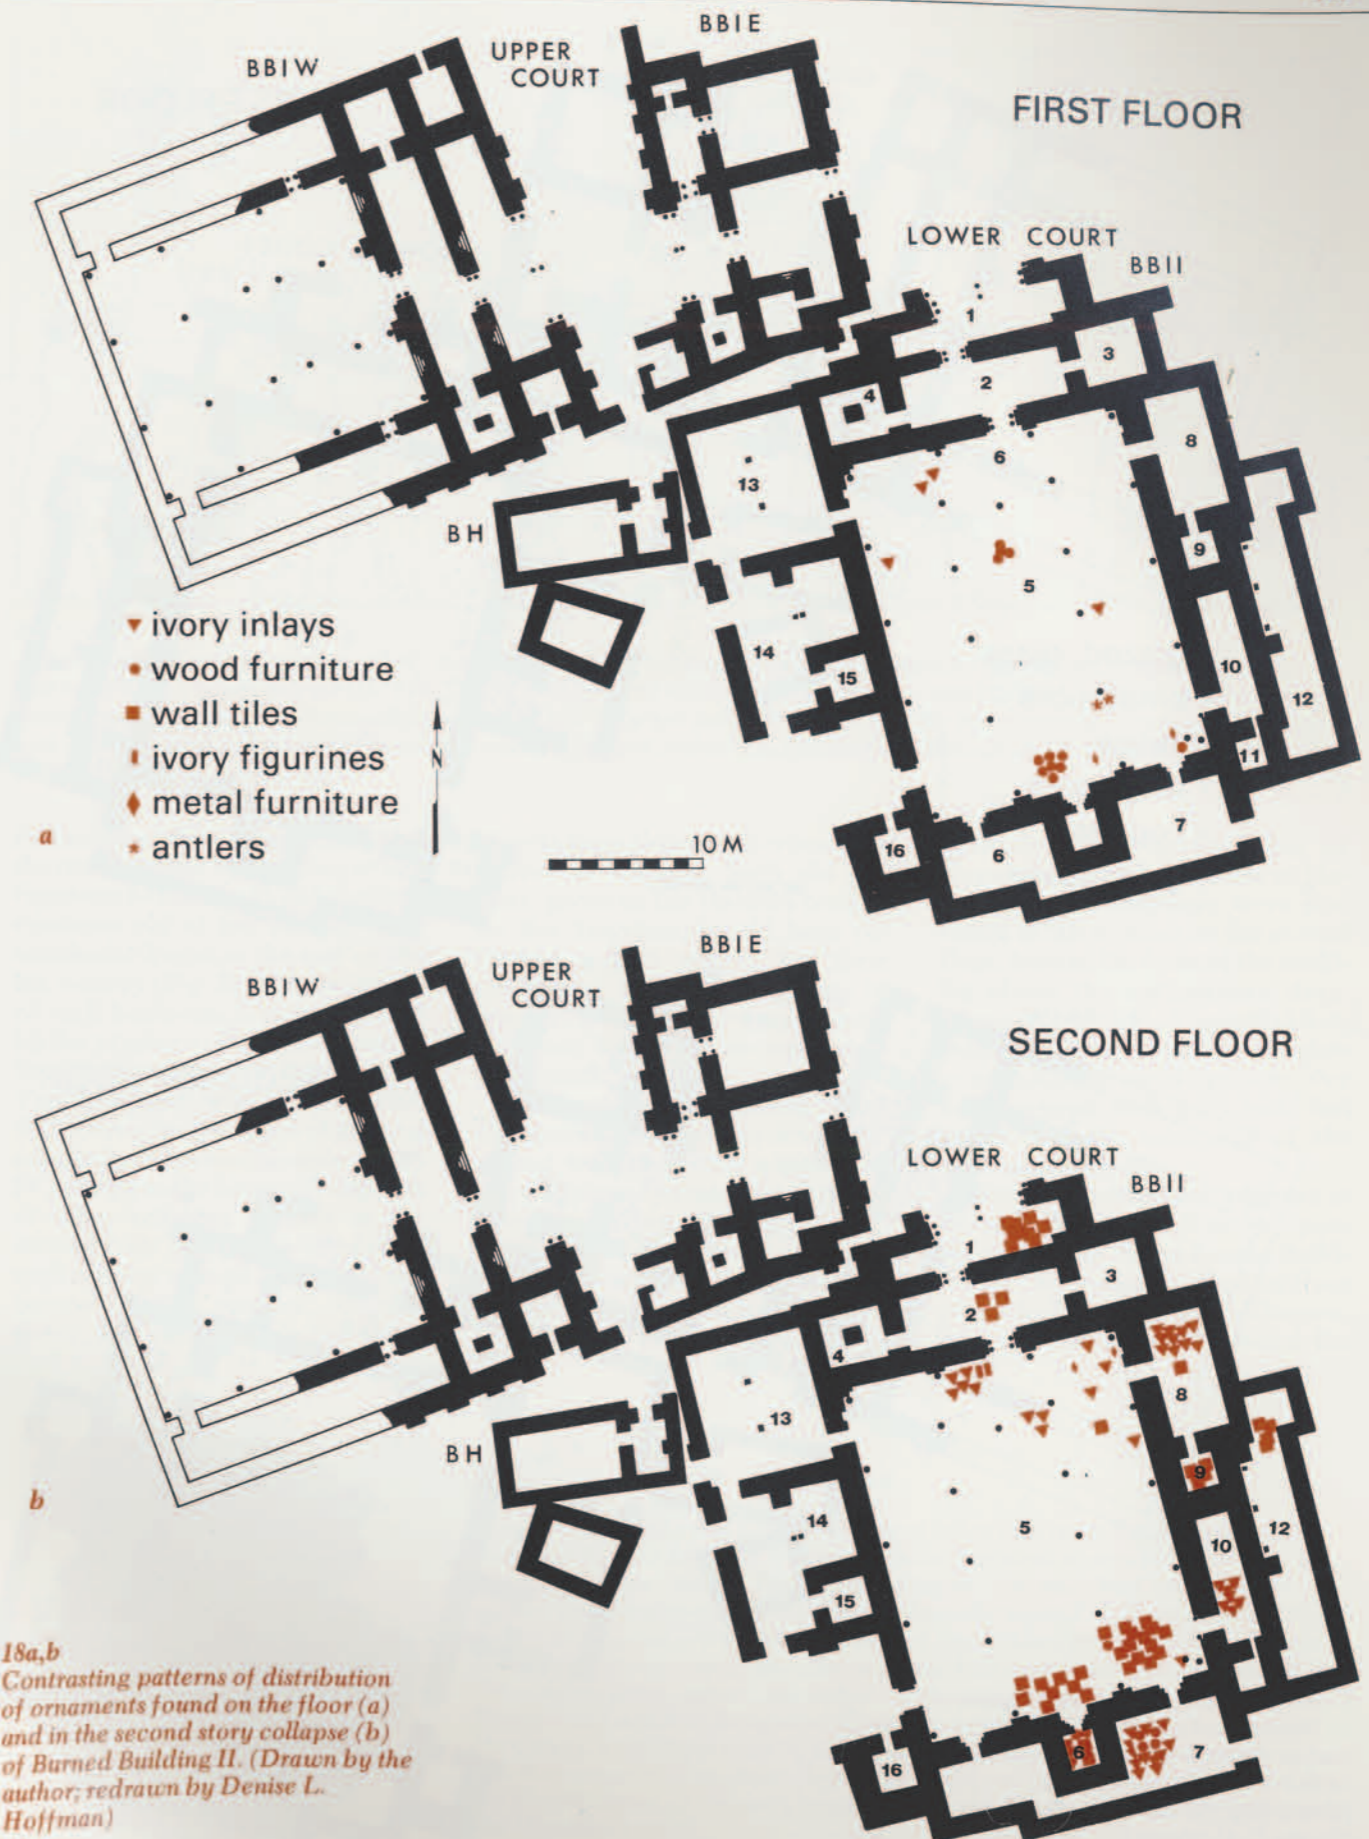
18a,b
Contrasting patterns of distribution of ornaments found on the floor (a) and in the second story collapse (b) of Burned Building II. (Drawn by the author; redrawn by Denise L. Hoffman)

As an example of this approach, let us examine the distribution of selected ornamental items in Burned Building II (Fig. 18a, b). On the first floor are a few pieces of ivory inlay, charred pieces of shaped wood, copper furniture attachments, a tall iron lamp with tripod feet, and red deer skulls complete with antlers. The wooden items included inlaid plank fragments and lathe-turned legs from a piece of furniture; some of the inlays and copper attachments also probably came from other pieces of furniture used in the columned hall. Two ivory inlays in the shape of eyes had a very different function, and may provide an additional key for the interpretation of the room and its contents: using texts from Mesopotamia, these inlays may be interpreted as the eyes of a cult figure, a deity who resided in Burned Building II (Fig. 20).

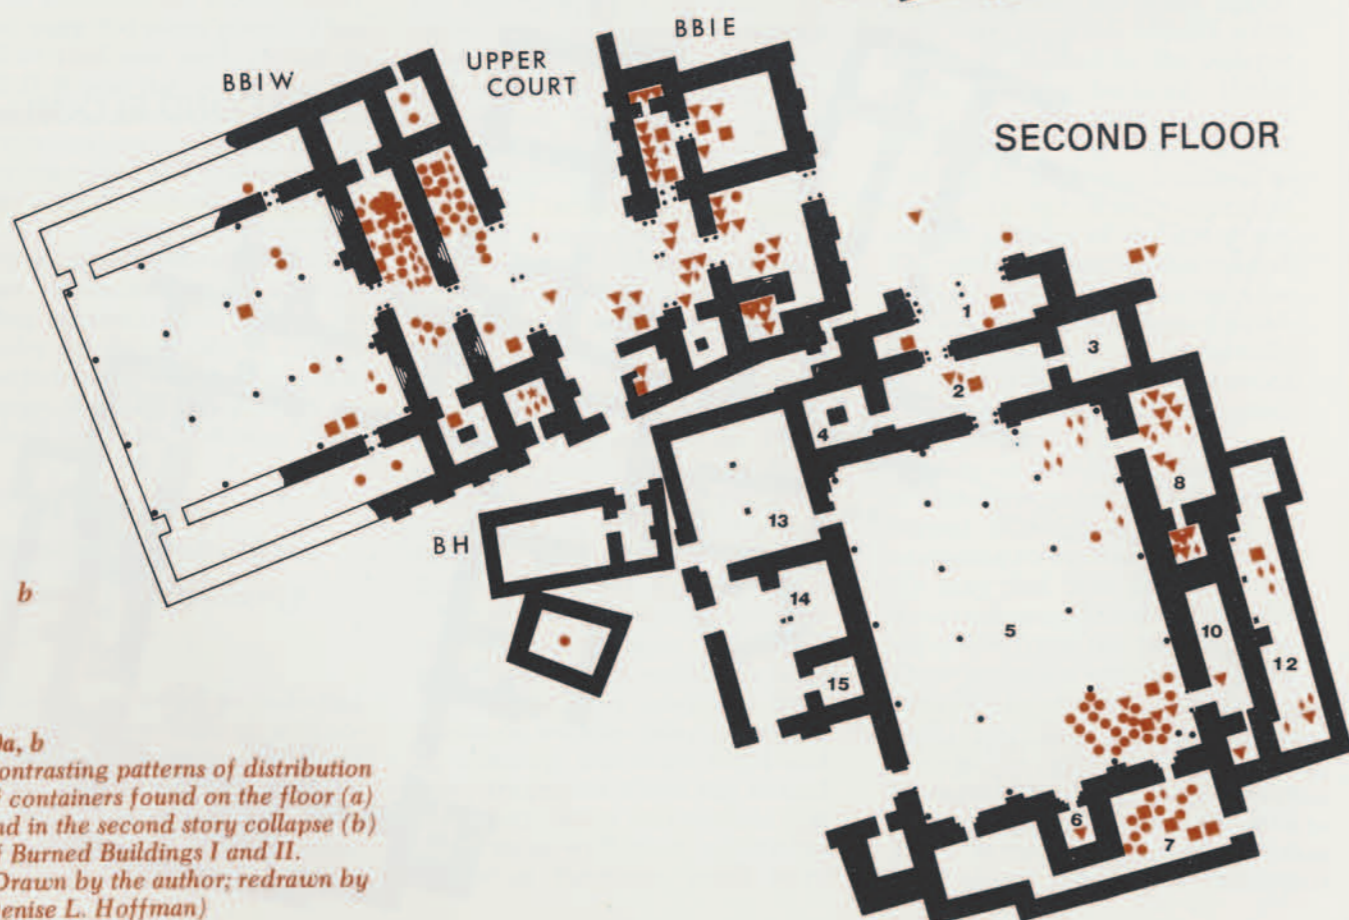
19a, b
Contrasting patterns of distribution of containers found on the floor (a) and in the second story collapse (b) of Burned Buildings I and II. (Drawn by the author; redrawn by Denise L. Hoffman)

When we turn to the distribution of containers on the second floor of Burned Building II, we find an interesting contrast to the first floor. We may first note that all of the stone containers found in this building come from the second floor. These include a vessel bearing the name of a Kassite king, Kadashman-Enlil (Pigott, Fig. 16, this issue); two kings of this name ruled in southern Mesopotamia, dating the container between ca. 1360 and 1255 B.C. This fragment, along with several other objects dated to the late 2nd

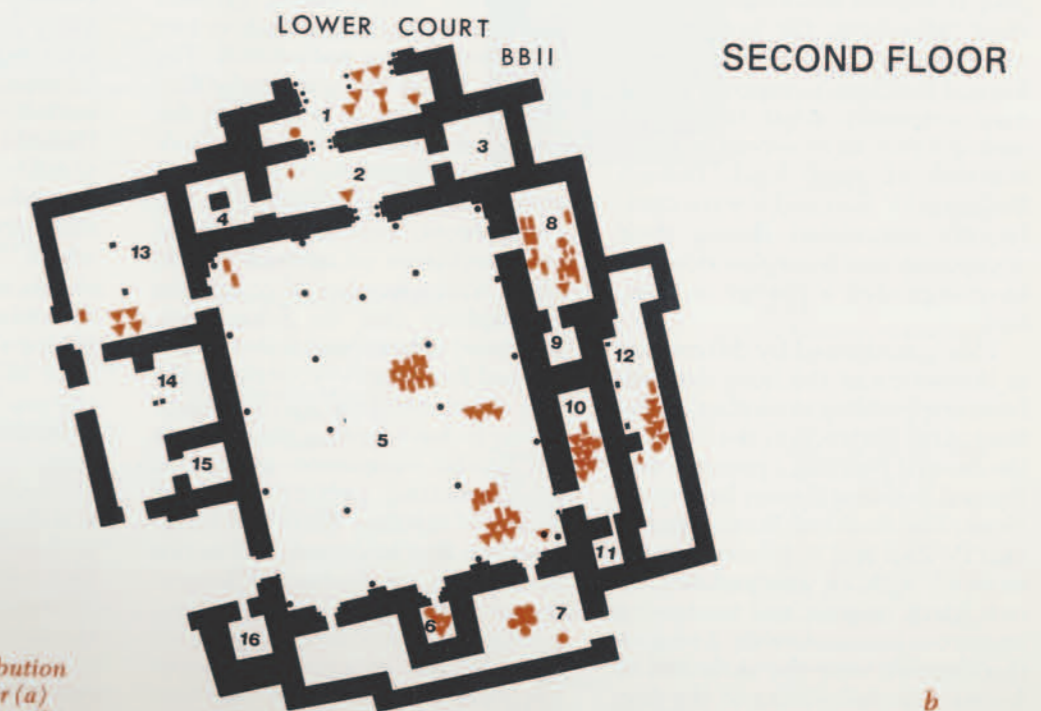
- ▼ arrowpoints
- maces
- ▬ spears, pikes
- ◆ swords, knives
- ★ armor

23a,b
Contrasting patterns of distribution of weapons found on the floor (a) and in the second story collapse (b) of Burned Building II. (Drawn by the author; redrawn by Denise L. Hoffman)

Another category of artifacts, weapons, provides a pattern of some interest. Figures 23a and 23b show the distribution of weapons in Burned Building II, including arrowheads, blades, maceheads, spearheads, and armor. Within the columned hall on the first floor, the distribution corresponds primarily to the location of a group of individuals lying at the north end of the room, who were presumably wearing or carrying these items. The location at the time of the building's collapse does not, therefore, represent the location of these weapons in the building during normal use.
