# ARCHITECTURAL CONSERVATION *at Gordion*

BY ELISA DEL BONO

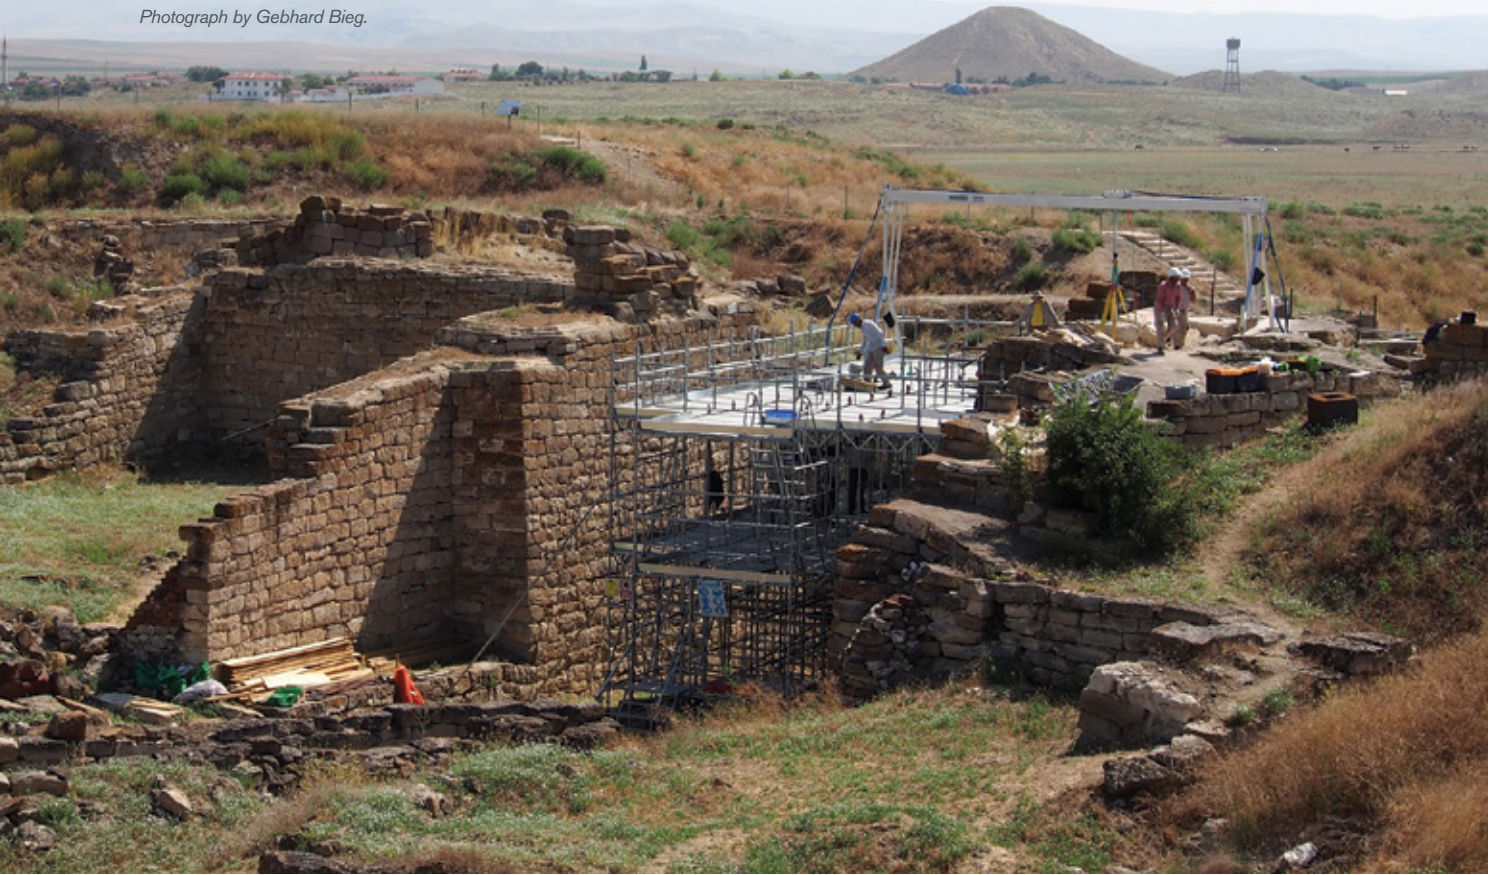
Conservation of the Early Phrygian Gate, looking west. In the background are the dig house compound (UPPER LEFT) and Tumulus MM (RIGHT).  
*Photograph by Gebhard Bieg.*

tion with structural engineer David Biggs, aims to strengthen and stabilize the Gate. Installation of a soil sub-base, a timber mat as scaffolding foundation, and metal scaffolding were completed in 2014. Conservation was begun during the 2015 field season, including masonry repointing, partial dismantling of highly displaced blocks, and stabilization of original blocks. In 2016, we will continue our important work at Gordion, concentrating again on archaeological conservation and site improvement for visitors. ●

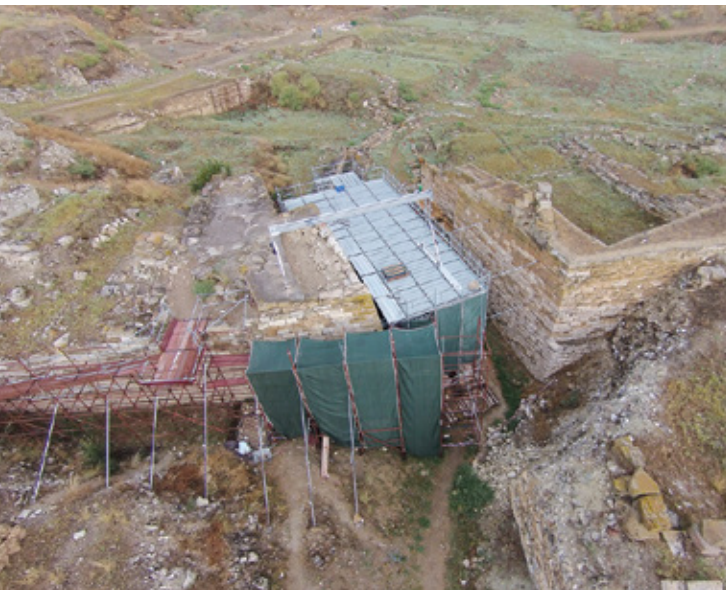
TOP: Members of the 2015 team work together to conserve masonry at the Citadel Gate. Photograph by Elisa Del Bono. BOTTOM: Aerial view of the Early Phrygian Gate during conservation work. Photograph by Lucas Stephens, 2015.

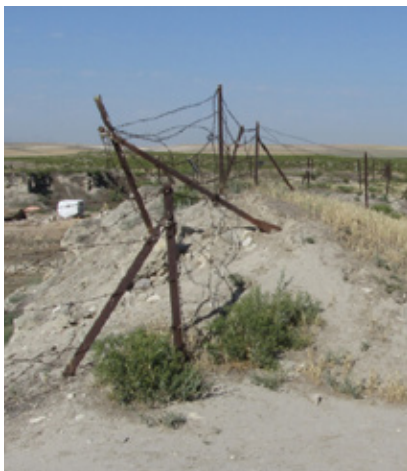
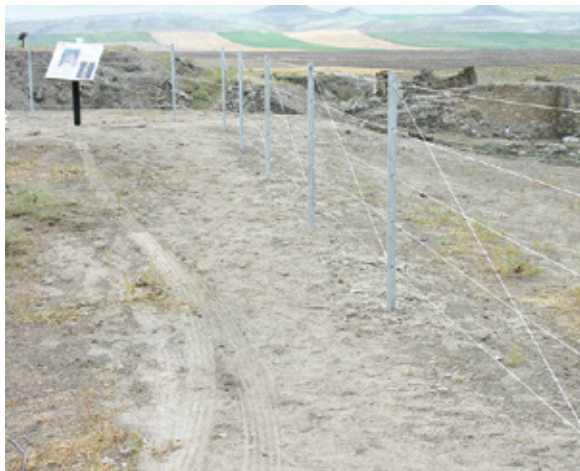
The old rusted fence (left) was replaced recently with a new fencing system and signage (right) along the visitor circuit.

Encircling the site from atop the escarpments, the visitor circuit provides viewing access into the Citadel Mound excavation and outward to the surrounding landscape. Efforts since 2009 have focused on upgrading public access by installing new perimeter railings, stone steps, and signage. The upgrades have created a more welcoming experience for visitors, establishing a connection between the Citadel Mound and the rest of the site while improving the interpretation and understanding of architectural and archaeological features. To date, a new perimeter railing and stone steps have been installed along half of the visitor circuit. In addition, 11 new bilingual (Turkish and English) information signs were installed around the Citadel Mound, giving visitors access to the full history of Gordion's settlements.

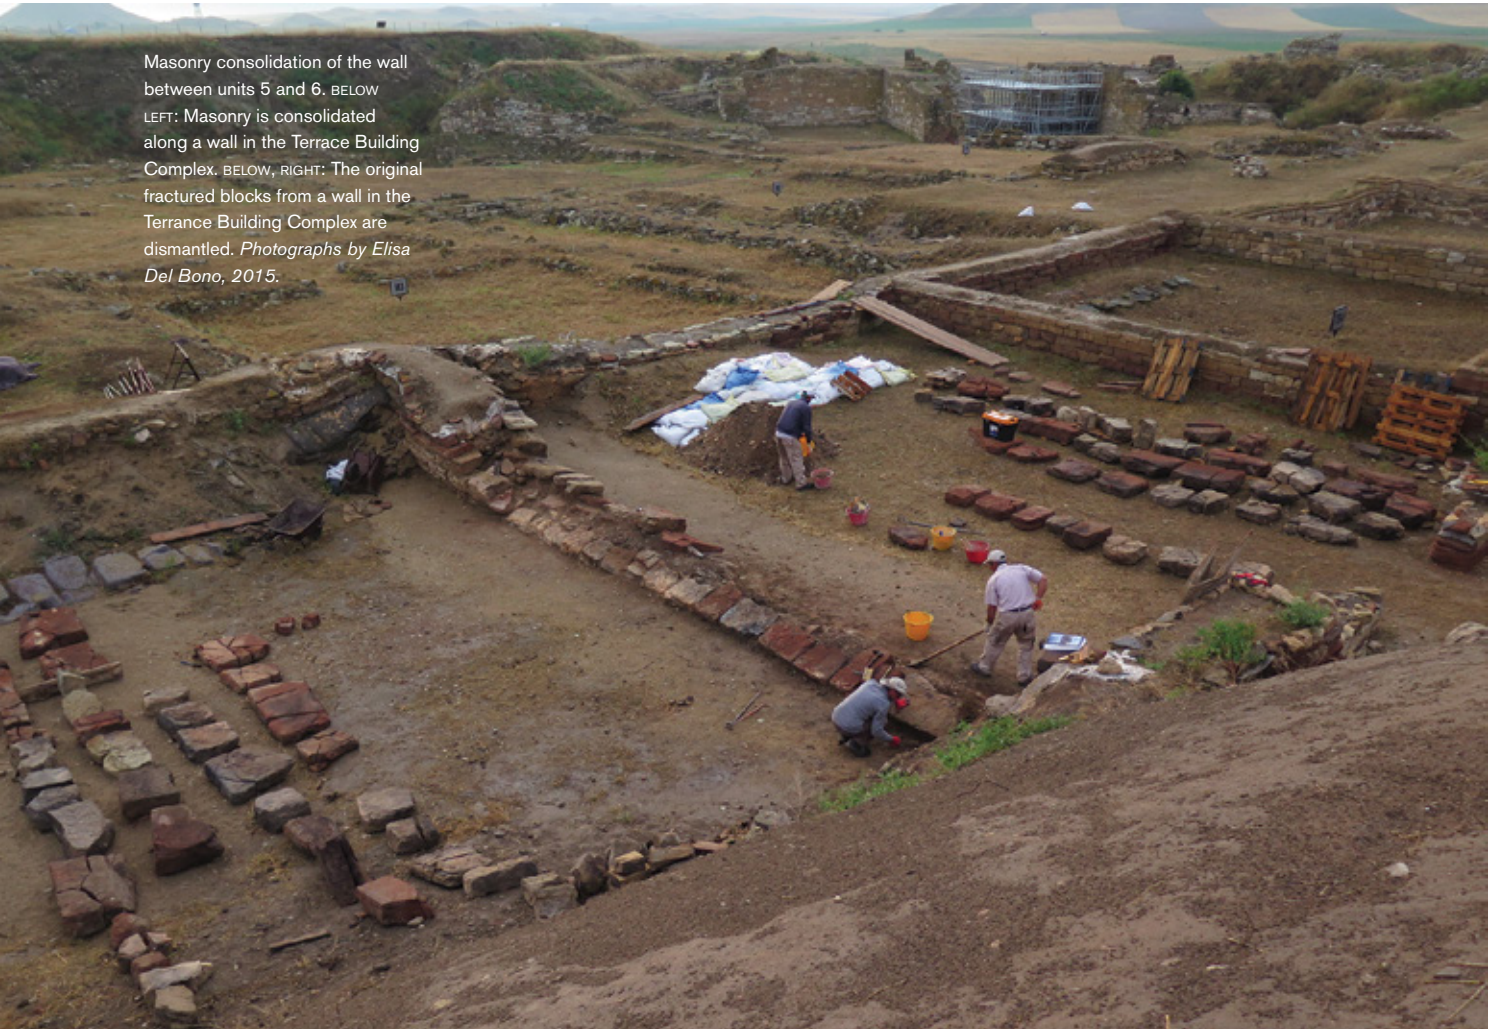
Masonry consolidation of the wall between units 5 and 6. BELOW LEFT: Masonry is consolidated along a wall in the Terrace Building Complex. BELOW, RIGHT: The original fractured blocks from a wall in the Terrace Building Complex are dismantled. *Photographs by Elisa Del Bono, 2015.*

The Terrace Building Complex is an industrial zone of Early Phrygian date (9th century BCE). The walls of these buildings were heavily damaged in the conflagration that swept through the complex in 800 BCE. In 2009, the site program explored new methods for conservation and preservation of the complex without compromising the archaeological integrity of the existing walls and floors. A pilot conservation program on the walls in Terrace Building 2 was established to stabilize the walls in situ, improve the visitor's understanding of the original building, and limit the need for continued interventions. In the course of seven field seasons, the consolidation of walls from the first to the fifth units was completed. Conservation techniques included the use of epoxy resins as adhesives and for grout injections of fractured stones, pinning and cable support of dislodged stones, and the installation of soft "vegetative" wall caps—in consultation with

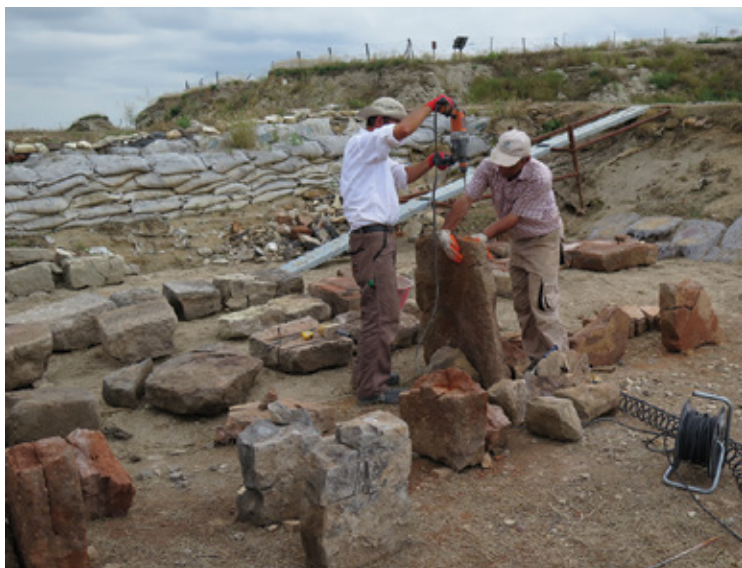
TOP: Blocks are treated during conservation. Photograph by Elisa Del Bono, 2015.  
MIDDLE: The wall separating rooms 5 and 6 of the Early Phrygian Terrace Building, prior to conservation in 2015.  
BOTTOM: The wall separating rooms 5 and 6 of the Early Phrygian Terrace Building, at the end of conservation in 2015. Photographs by Gebhard Bieg.

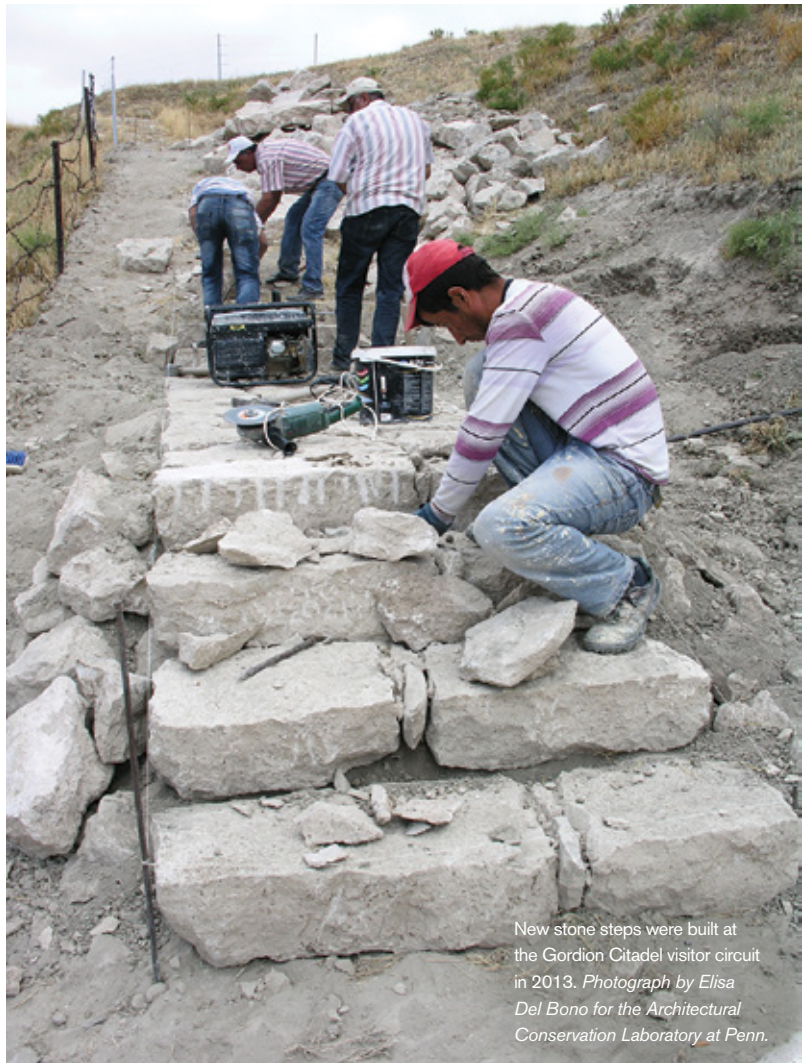
New stone steps were built at the Gordion Citadel visitor circuit in 2013. Photograph by Elisa Del Bono for the Architectural Conservation Laboratory at Penn.
