The Restoration of a Bronze Plaque from Benin

By LESLIE R. LANGTON

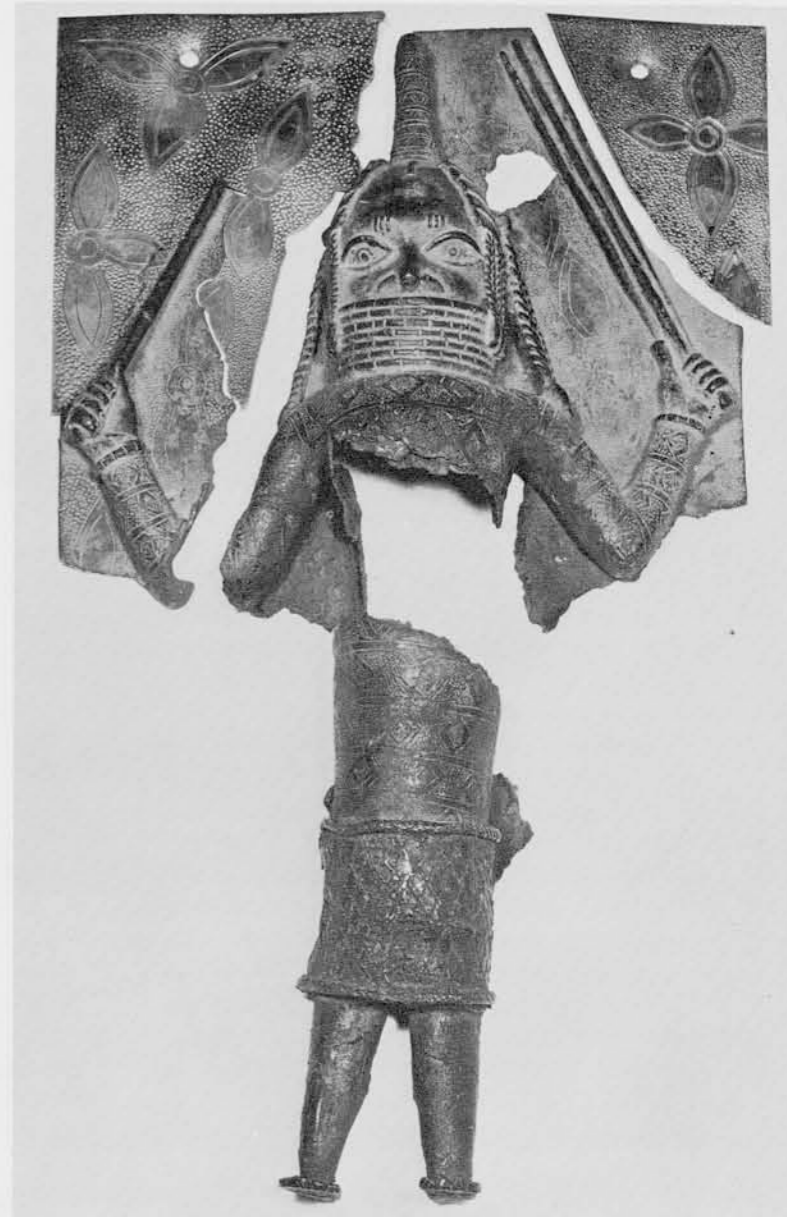
The 15th-16th century bronze was in excellent condition consistent with its age, except for the area between the elbows and from 1 cm. above the fracture across the chest down to the 19th century casting. This area was extremely thin—1 mm. to 0.25 mm.—and in very poor condition, being partially mineralized and 'burnt', due most probably to overheating during the 'burn-on' casting of the skirt and legs, which was 3 mm. to 5 mm. thick and in excellent condition.

between them was in such poor condition that whatever method was used for repair the bronze itself would not support the weight of the upper and lower areas of the plaque.

As mentioned previously, our examination showed a very weak area in the centre of the figure and now the right arm fragment needed support. It was finally decided to make up all the missing parts of the plaque in 3/16" bronze plate and hard solder all the edges together. In this way the weak areas would be 'bridged' and all the edges protected. The right hand fragment would be held firmly in its correct position to the face fragment and to the body at the hips. The cores would be visible from the reverse and the plaque restored to its original proportions.
