REMOVAL AND RESTORATION OF THE MONUMENTS OF CARACOL

Horace Willcox

The 1951 expedition of the University Museum to British Honduras brought out a substantial tonnage of Maya stelae and altars. With Seymour A. Nuddle, a fellow graduate student in the Department of Anthropology, I went along to help, officially as assistant archaeologist. This is the story of the practical problems in getting the material ready for shipment, at the site which is called Caracol, and in restoring the Museum's share of the monuments.

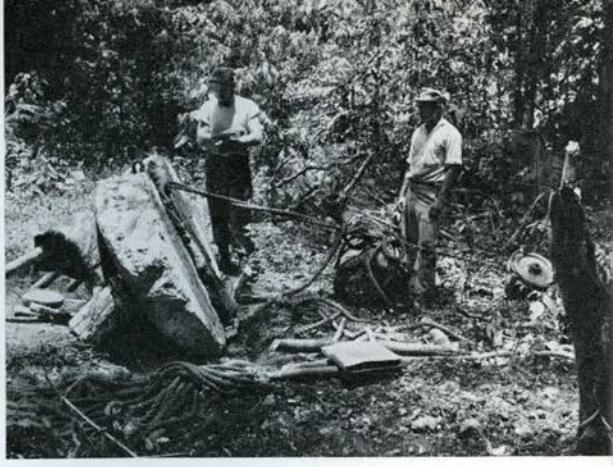
Figure 49. Large fragment of Altar 6 being readied for night photography, showing use of chain hoist, protective padding, bracing technique.

Obviously many "straight-on" views were needed, without foreshortening. To get them, the stones were set on their narrow edges and braced from behind (Fig. 49). Their handling in this position was surprisingly facile. Thus either the fragment itself, or the camera, could be quickly adjusted so that the lens position was at right angles to the sculpture.

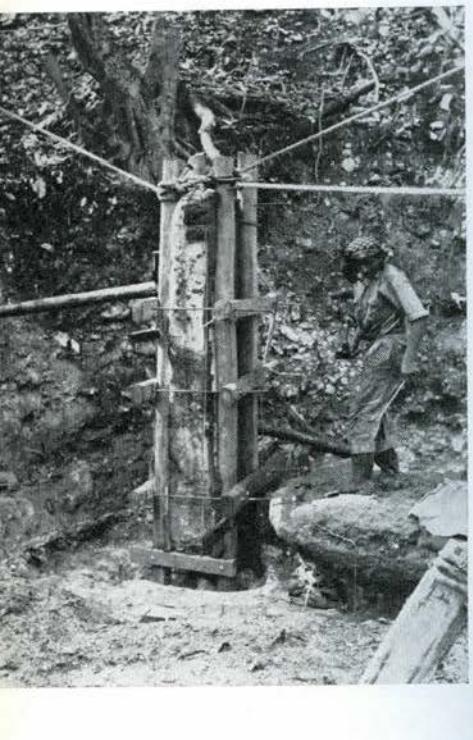
Figure 50. (Left) Stela 1 held in position with ropes, its "pressure crate" partially completed. Workman stands on Altar 1. Neither monument has yet moved from its original position.

The larger stones were put into "pressure crates." These consisted of two wooden platforms of similar construction. Each was placed against a broad face of the stone and bolted together with half-inch threaded iron rods, brought for the purpose. Naturally, with the fragments already on edge, it was no trick to dig shallow trenches on each long side, wedge the two sections into the proper position and screw down the nuts. Thus, with these sections drawn tight, the stone rested somewhat like an oyster within its external skeleton (Figs. 52 and 63). All the wood had previously been measured, cut and drilled at camp. The scale drawings

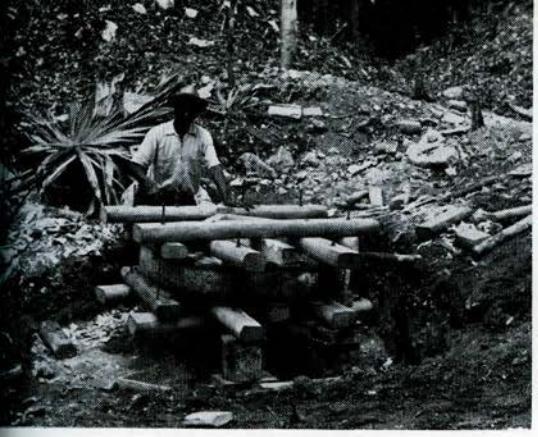
Figure 52. Altar 7. The carpenter, Gumersindo Requena, tightens bolts on the nearly finished "pressure crate."

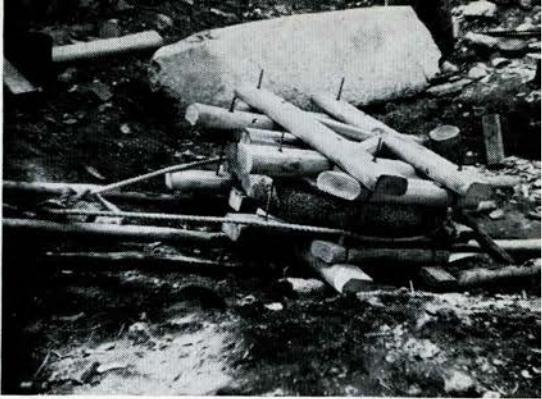
Figure 53. Pulling the crated monument from its original position on "rails." Stela 14, in background, has been moved.

The altars, naturally, entailed no such positional problems after breakage; fractured or not, there was little danger to the relief in moving them. But, at Caracol, caches of religious offerings were known to have been secreted under some of the altars. Therefore, when removing fragments, it behooved us not to burrow haphazardly under them. Both unbroken altars were packaged in situ like Stela 1. In essence, this involved raising jacking up—the altar onto "legs" of wooden blocks (Fig. 52). This meant, of course, that the area under the stone remained undisturbed, and, after crating, the altar could safely be moved off on "rails" (Fig. 53).

The majority of the fragments were dragged to their more convenient locations by a "Yale" chain hoist of 1½-ton capacity. The machine could be carried by two men when slung from a strong carrying pole. For dragging, the fragment, with a rope sling and pads about it and resting on a temporary wooden sledge-like platform, was hooked to the previously anchored hoist (Fig. 57). Long poles, with bark removed, were laid parallel on the ground, often with wooden stakes driven in beside them to prevent undue skew. The "rails" were greased. Then the fragments slid quite unconcernedly (Fig. 53).

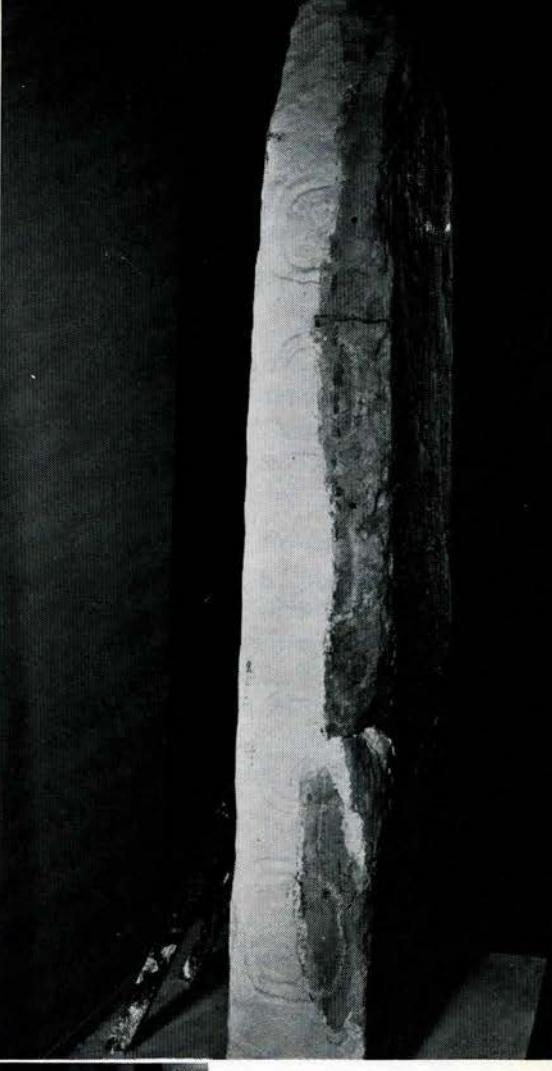
Figure 61. (Below) Building up the lowest unit on the iron base.

Mr. Jehle designed a "rest" of steel plate, a little larger than the butt of the stela, which was welded firmly on the long sides to 2½-inch angle iron. This in turn was bolted down to four pairs of angle irons which were the width of the "rest" and which lie on the floor, thus taking the weight. The two central pairs had in cross-section the form of a letter "T," split vertically; the two end pairs formed the letter "C" (Fig. 61). This did not complete the support, however—and more about it shortly.

To obtain a nearly perfect balance, four threaded pins five inches long were run up through the flat bottom of the steel "rest" and into shallow holes in the bottom of the stela. By adjustment of nuts on these bolts upward or downward, satisfactory balance was obtained. Previously, four threaded pins had been set into the butt and their free ends protruded downward through the "rest." With the last of the minute adjustments, Densite was forced into all of the cavities between the stone and the flat "rest." Nuts were run up the four free pins and tightened. The butt of the stela and the "rest" thus became a single unit and remain so until one loosens the nuts.

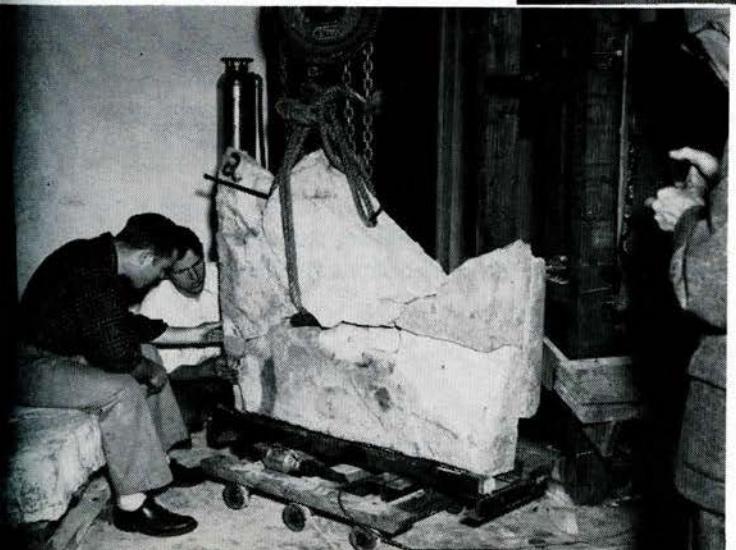
Figure 62. (Above) The job done—finis for this one. Well nigh every stela had its own set of specific problems and difficulties. The collapse of Stela 5, for example, had left one section resting directly on top of another (Fig. 56). Here the jack was used, in conjunction with braces, so that the stone eventually sat on four wooden "legs," and the rail technique could then be utilized.

Stela 5, it will be recalled, had broken both horizontally and vertically and, as the back was plain, only the thin pieces bearing the sculptured face, and one other with legible glyphs, were brought home (Figs. 56 and 62). There were eight main fragments and some forty-six lesser chips and flakes. It was decided that four primary units, including the base, would constitute the most satisfactory reconstruction plan.

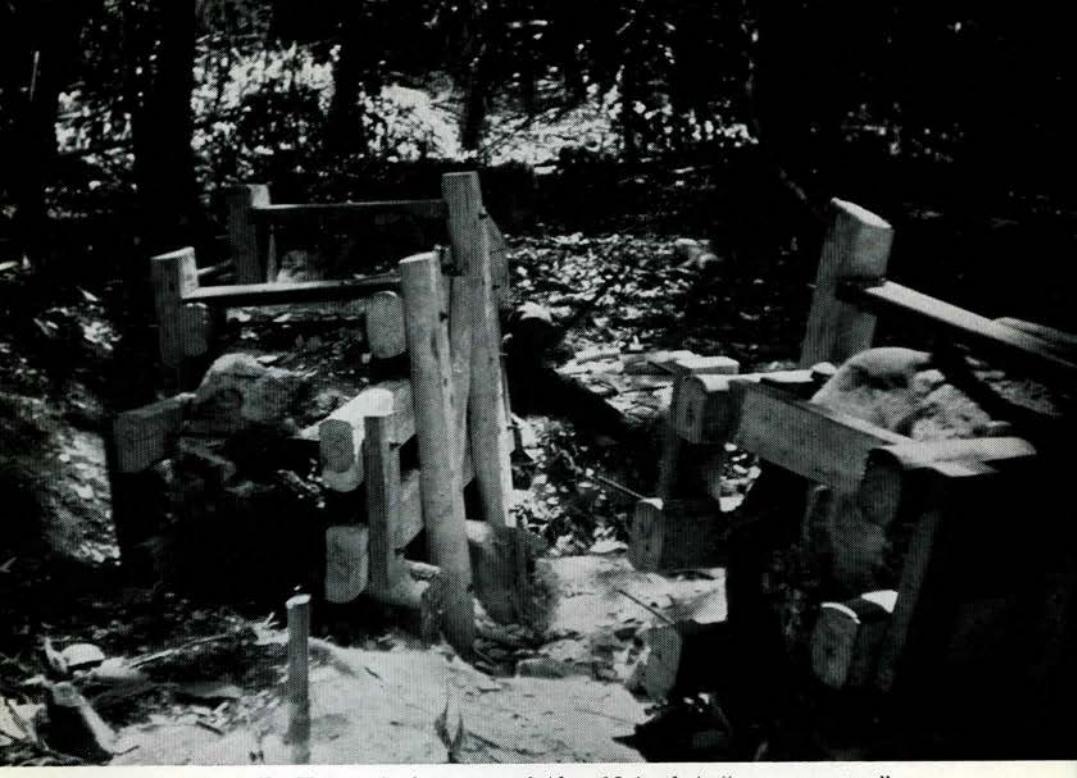
Figure 63. Two main fragments of Altar 12 in their "pressure crates." In left foreground, one of Nuddle's survey stakes.

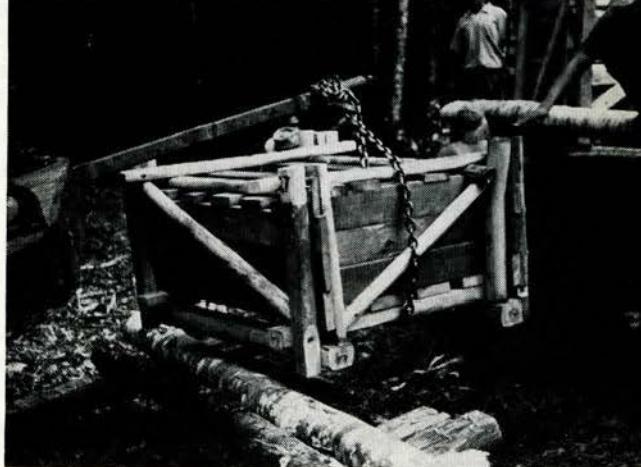
Figure 65. (Right) Detail of loading technique. When the treads of the bulldozer reach the logs the box will rise and the truck (at right) will back under it.

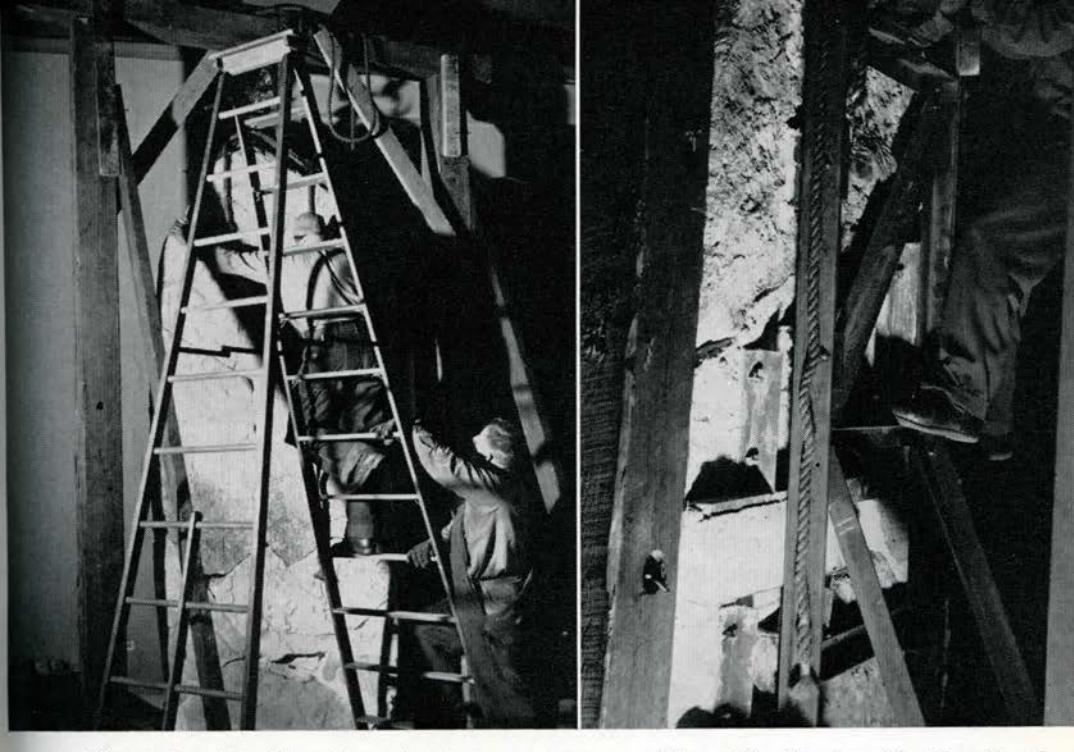
Figure 66. Assembling the restored "primary units" of Stela 5. Figure 67. The iron "backbone" and plaster reinforcing of Stela 5 as erected.

Before the units could finally be erected for display, a vertical steel frame was necessary to prevent the thin assembled fragments from toppling over. This was behind the face where it would not be seen. Two "basal extensions" of angle iron were laid on the floor, slid between the "split uprights" of the central "T" supports of the "rest" so as to extend some twenty inches out behind the stela, and bolted to the supports. Then two pairs of cross-braced angle irons were erected vertically and bolted to the "rest" at the bottom. More angle iron was run from the middle of these verticals downwards and backwards to the extremes of the basal extensions so that the vertical steel frame could not move (Fig. 67). When the stela was assembled, the vertical iron members were bolted to steel plates, welded to pins previously "Densited" into the backs of the primary units of the monument.

Stela 5 necessitated some thirty-four exact alignments and over thirtysix feet of holes were drilled into the brittle limestone. Approximately eighty feet of angle iron went into the assembly. Without doubt, Mr. Jehle has here done a very fine job.
