Repairing Damage Inflicted by the Persians 2,500 Years Ago

SUMMER 2021 ARCHITECTURAL CONSERVATION WORK AT GORDION, TURKEY

BY C. BRIAN ROSE

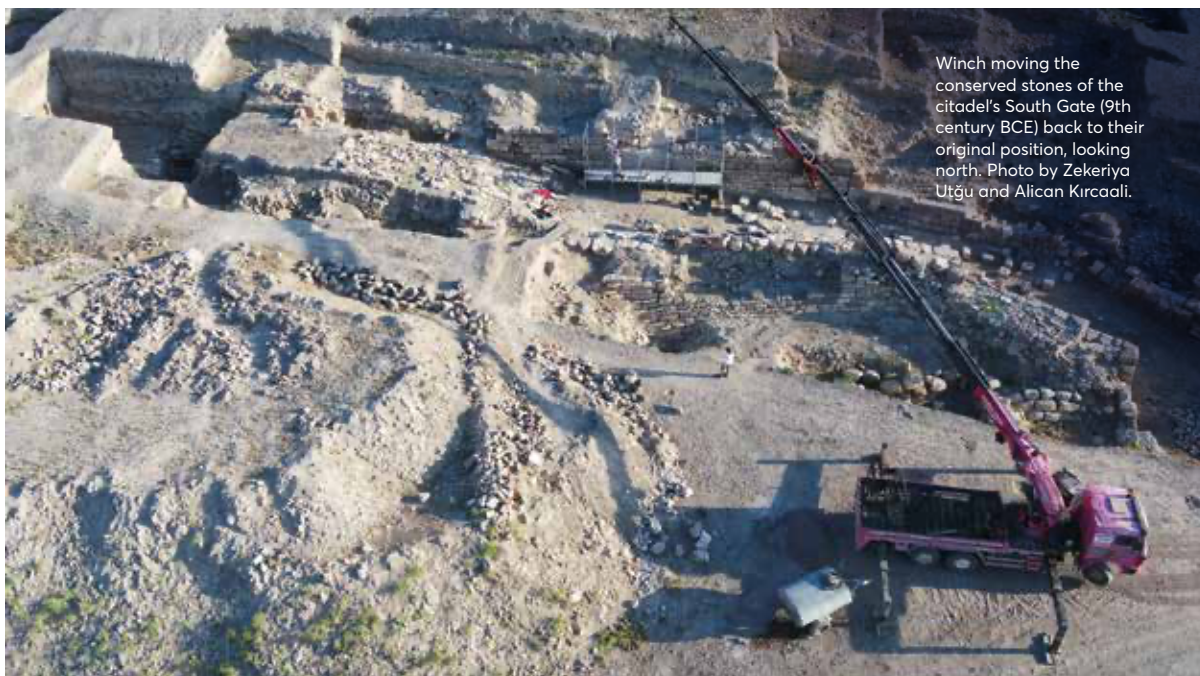
Winch moving the conserved stones of the citadel's South Gate (9th century BCE) back to their original position, looking north. Photo by Zekeriya Utğu and Alican Kırcaali.

Each of the stones had to be consolidated before we repositioned them on the wall and the restored facing courses were then anchored to the rubble core by steel straps. Altogether, 43 newly stabilized stones were assembled in 12 wall courses, and the northern side of the approach road is once again defined by the same handsome limestone facing it once possessed.

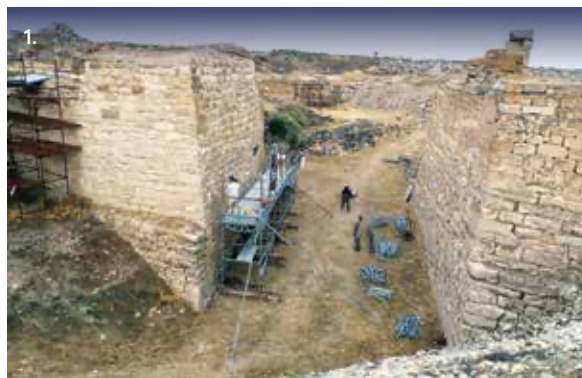
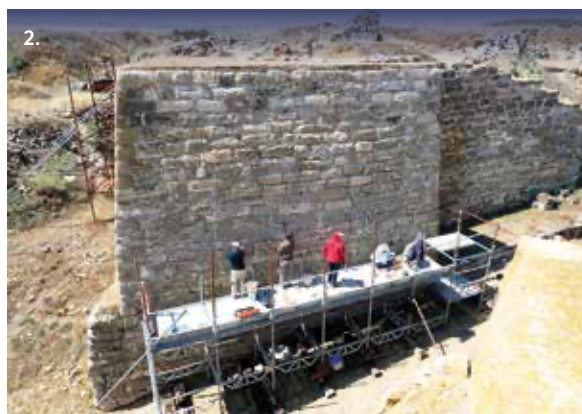
(1) Conservation at the citadel's East Gate (9th century BCE), looking west. Photo by Brian Rose. (2) Conservation of the East Gate's South Bastion, looking south (9th century BCE). Photo by Brian Rose.

Our architectural conservation priorities were the two monumental citadel gates: the Early Phrygian **East Gate** and the multi-period **South Gate**, both of which were built in the mid-9th century BCE and subsequently damaged by earthquakes. This year we completed our multi-season conservation program for the 10 m (33 feet) high **East Gate**, the highest and best-preserved Iron Age citadel gate in Asia Minor. The **South Gate**, which we have been excavating since 2013, has a monumental approach road along which King Midas himself will have passed. The gate was built ca. 850 BCE, refurbished in the 8th and 6th centuries BCE, then rebuilt again in the 4th century CE, so it was in operation for over 1,200 years. The approach road was over 65 m (213 ft) in length, making it the longest known approach road of any citadel gate in Asia

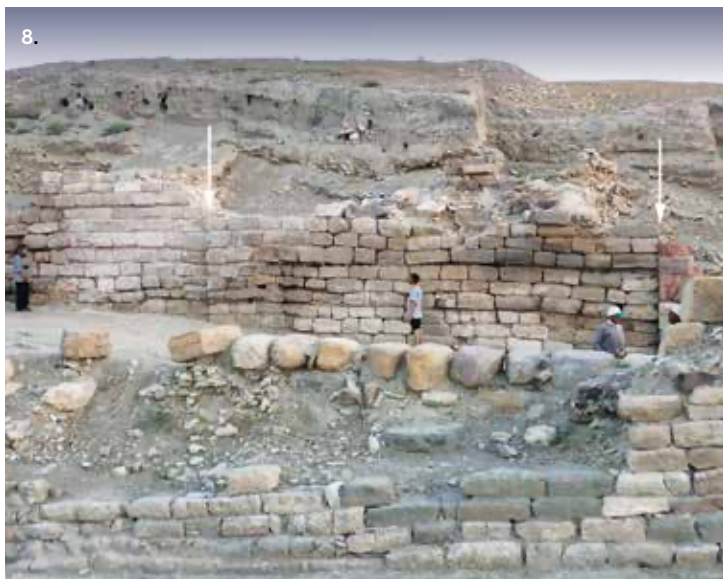
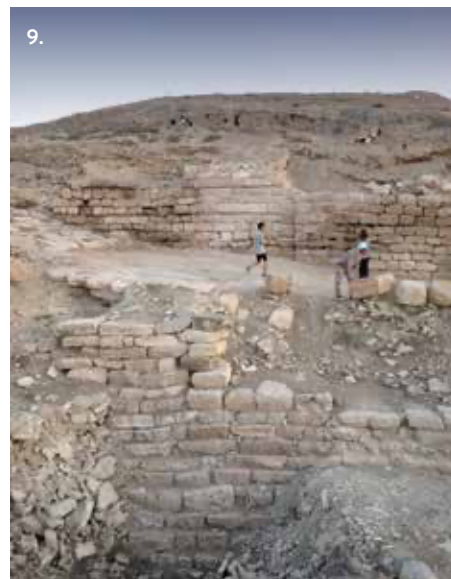
(8) The newly conserved north wall of the South Gate (9th century BCE), with the conserved segment on the left (compare to figure 5). The arrows indicate vertical offsets in the wall. (9) The newly conserved north wall of the South Gate (9th century BCE), with the glacis (stepped revetment wall) in the foreground. Photos by Brian Rose.

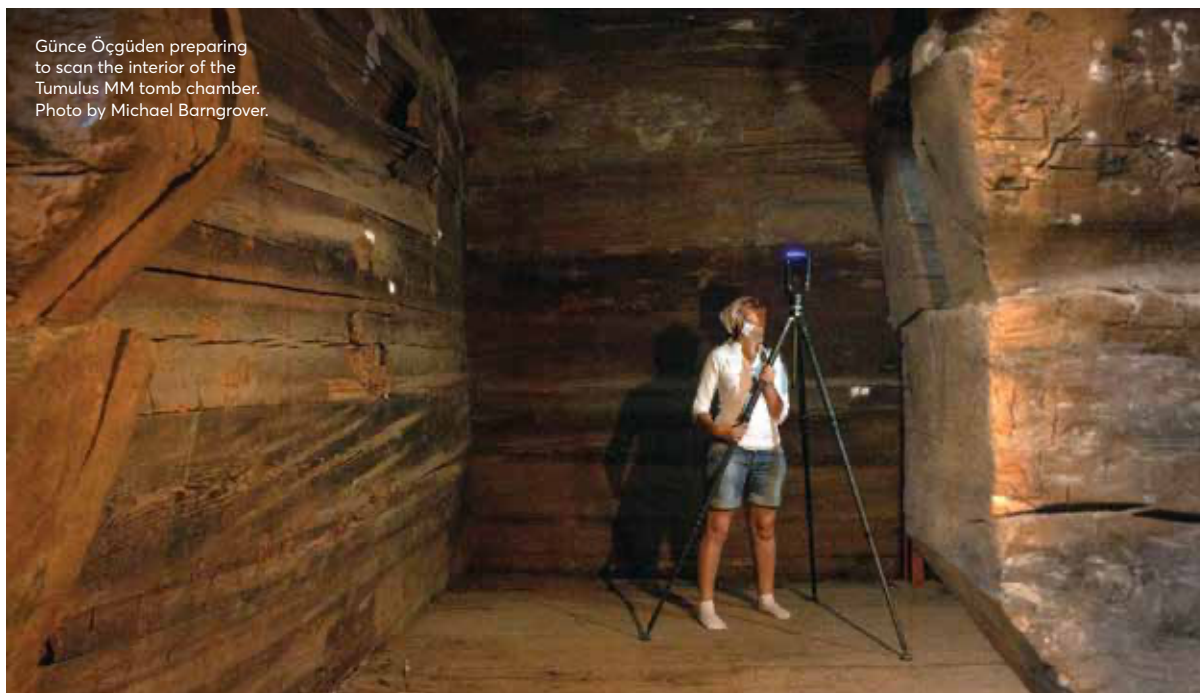
Günce Öçgüden preparing to scan the interior of the Tumulus MM tomb chamber. Photo by Michael Barngrover.

We completed the first phase of laser scanning the Tumulus MM (Midas Mound) tomb chamber, the oldest standing wooden building in the world, including all of the chamber's interior and much of the exterior (to be finished in 2022). The aim is to produce a comprehensive and accurate record of the monument as well as a digital reconstruction of what it looked like ca. 740 BCE during the funeral of a man whom we identify as King Midas's

father. The digital model will also be of great value to cultural heritage management in that we will be able to more effectively monitor deterioration that may occur over time. Furthermore, we can prepare an interactive tomb exhibition by using virtual and augmented reality technology. In this way, Gordion's many visitors can tour the burial chamber for the first time, something that was impossible before due to restricted access to the fragile wooden chamber.
